**Flood Control Project Maintenance
Levee Inspections****LMA District Cover Sheet****Spring 2014 Levee Inspection Results****Reclamation District No. 0563 Tyler Island**

Spring 2014 Levee Inspection Results

Reclamation District No. 0563 Tyler Island

Waterway			Bank	Unit Miles
Unit No. 01 Georgiana Slough (Tyler Island)			Left	12.38
	Spring (March - May)	Summer (June - August)	(September - November) Fall	Winter (December - February)
Unit Maintenance Rating (Fall Only)				
Date of Inspection	03/25/2014 - 03/26/2014			
DWR Inspector	Richard Willoughby			
Accompanied By	Steve Mello RD 563

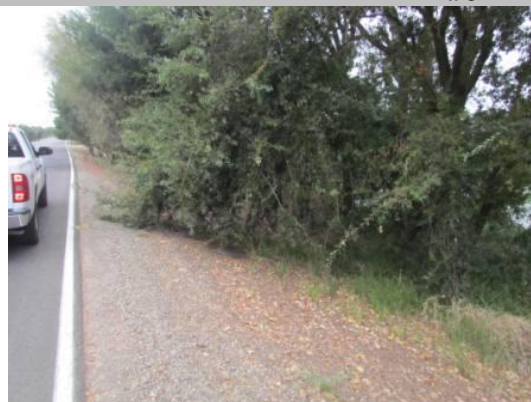
Photo 1 of 1 : richard_s_20140318_786.jpg

LM Start	0.13	Rating **	A/W	Issue No.	4
LM End	0.13	Issue Type +	Ma	Location *	WS
Category	Earthen Levee			GPS Latitude/Longitude	
				Start	End
Item	Trim / Thin Trees			38.234018 °	38.234018 °
				-121.518547 °	-121.518547 °
DWR ID	DWR_RD0563_01_s _ 2012_4				
Action/Comments					
Trim trees to at least five feet above ground level.

Looking southwest at overgrown tree on waterside slope.

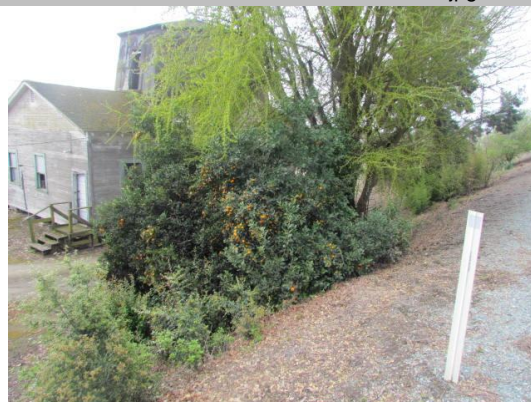
Photo 1 of 2 : richard_s_20140318_812.jpg

LM Start	0.14	Rating **	M	Issue No.	28
LM End	0.16	Issue Type +	Ma	Location *	LS
Category	Earthen Levee			GPS Latitude/Longitude	
				Start	End
Item	Trim / Thin Trees			38.233910 °	38.233655 °
				-121.518722 °	-121.519000 °
DWR ID	DWR_RD0563_01_s _ 2012_28				
Action/Comments					
Trim trees to at least five feet above ground level.

Looking southeast at landscaping on landside slope and toe.

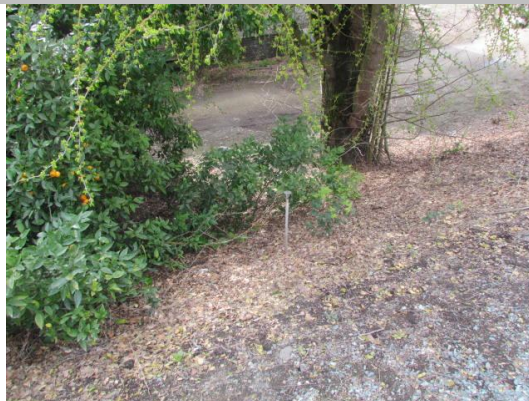
Photo 2 of 2 : richard_s_20140318_813.jpg

LM Start	0.14	Rating **	M	Issue No.	28 (cont)	
LM End	0.16	Issue Type +	Ma	Location *	LS	
Category	Earthen Levee			GPS Latitude/Longitude		
				Start		End
Item	Trim / Thin Trees			38.233910 °	38.233655 °	
				-121.518722 °	-121.519000 °	
DWR ID	DWR_RD0563_01_s_2012_28					
Action/Comments						
Trim trees to at least five feet above ground level.

Looking east at sprinklers on landside slope.

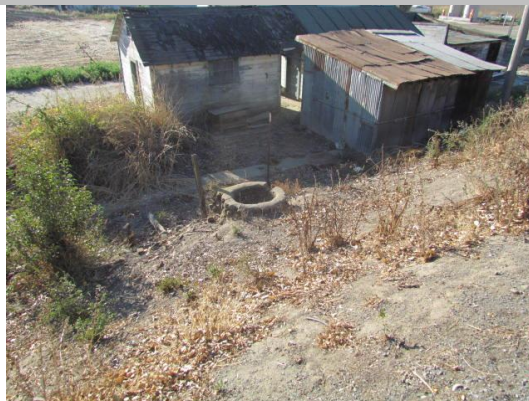
Photo 1 of 3 : richard_s_20140318_793.jpg

LM Start	0.17	Rating **	M	Issue No.	10
LM End	0.17	Issue Type +	En	Location *	LS
Category	Earthen Levee			GPS Latitude/Longitude	
				Start	End
Item	Encroachments			38.233572 °	38.233572 °
				-121.519083 °	-121.519083 °
DWR ID	DWR_RD0563_01_f_2013_10				
Action/Comments					
Building Inspector Comments: Tool shed and fire pit on landward slope and toe.

Looking east at fire pit on landward slope.

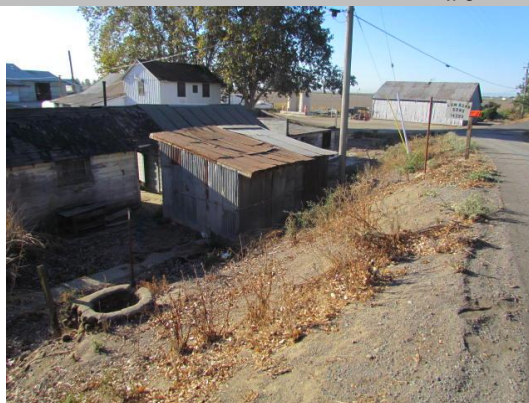
Photo 2 of 3 : richard_s_20140318_794.jpg

LM Start	0.17	Rating **	M	Issue No.	10 (cont)
LM End	0.17	Issue Type +	En	Location *	LS

Looking southeast at storage shed at landward toe.

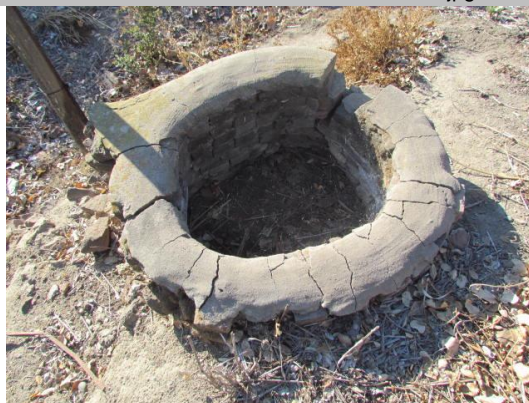
Photo 3 of 3 : richard_s_20140318_795.jpg

LM Start	0.17	Rating **	M	Issue No.	10 (cont)	
LM End	0.17	Issue Type +	En	Location *	LS	
Category	Earthen Levee			GPS Latitude/Longitude		
				Start		End
Item	Encroachments			38.233572 °	38.233572 °	
				-121.519083 °	-121.519083 °	
DWR ID	DWR_RD0563_01_f_2013_10					
Action/Comments						
Building

Looking southeast at fire pit on landward slope.

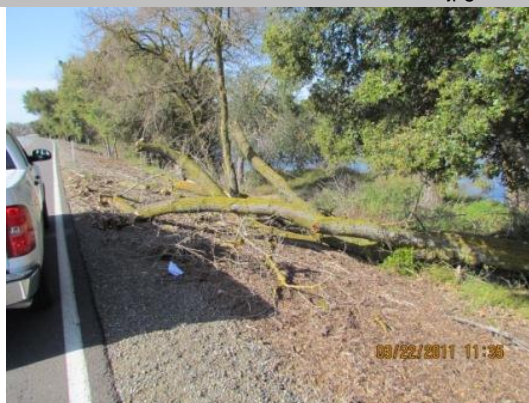
Photo 1 of 1 : richard_s_20140318_814.jpg

LM Start	0.19	Rating **	M	Issue No.	32
LM End	0.19	Issue Type +	Ma	Location *	WS
Category	Earthen Levee			GPS Latitude/Longitude	
				Start	End
Item	Encroachments			38.233315 °	38.233315 °
				-121.519360 °	-121.519360 °
DWR ID	DWR_RD0563_01_s_2012_32				
Action/Comments					
Tree or limb Inspector Comments: Tree fallen across waterward slope.

Looking south (downstream) at fallen tree limb on waterside slope.

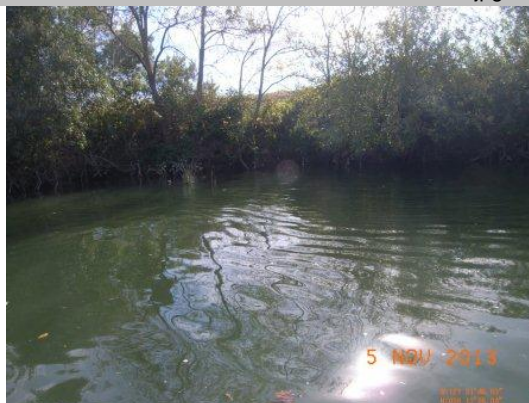
Photo 1 of 1 : USACE2013A_GEO_11-0_L_6.jpg

LM Start	0.35	Rating **	M	Issue No.	55
LM End	0.42	Issue Type +	Ma	Location *	WS
Category	Supplemental			GPS Latitude/Longitude	
				Start	End
Item	USACE Erosion Survey			38.226522 °	38.227157 °
				-121.529094 °	-121.530432 °
DWR ID					
Action/Comments					
Inspector Comments: 2011 - Short sections of eroding bank at the waterline and holes in toe of levee. 2012 - Site extended upstream. 2013: Erosion pockets filled with an insufficient amounts of revetment. [2013 Site ID: GEO_11-0_L]

USACE 2013 Photo #1

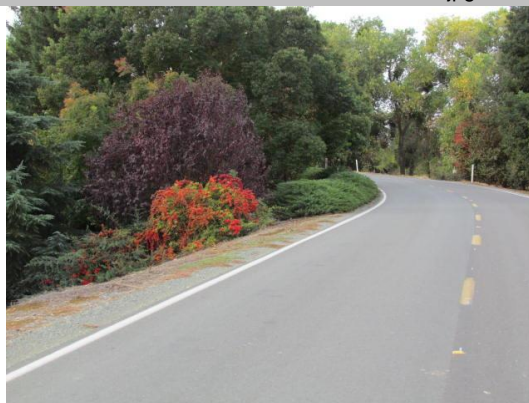
Photo 1 of 2 : richard_s_20140318_862.jpg

LM Start	0.68	Rating **	U	Issue No.	50
LM End	0.71	Issue Type +	En	Location *	LS
Category	Earthen Levee			GPS Latitude/Longitude	
				Start	End
Item	Vegetation			38.228033 °	38.227777 °
				-121.525268 °	-121.525627 °
DWR ID	DWR_RD0563_01_s_2012_50				
Action/Comments					
Landscaping

Looking southeast at dense landscaping on landside slope.

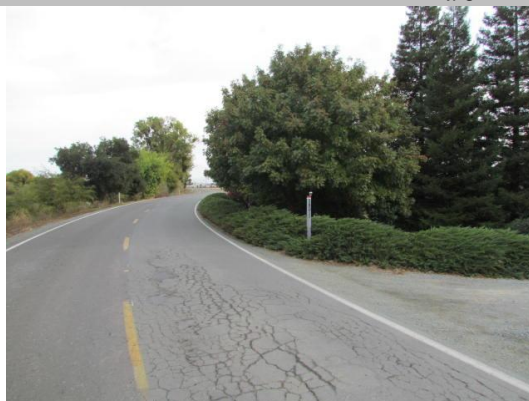
Photo 2 of 2 : richard_s_20140318_863.jpg

LM Start	0.68	Rating **	U	Issue No.	50 (cont)
LM End	0.71	Issue Type +	En	Location *	LS

Looking northwest at dense landscaping on landside slope.

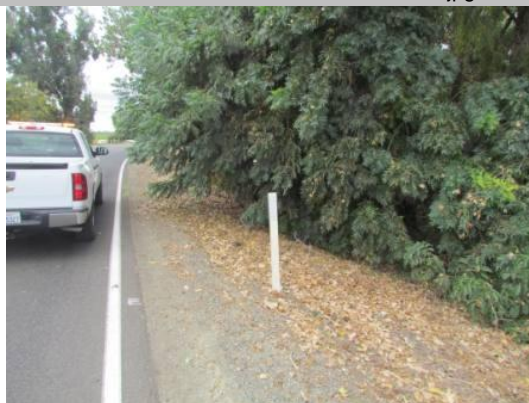
Photo 1 of 2 : richard_s_20140318_784.jpg

LM Start	0.80	Rating **	A/W	Issue No.	3
LM End	0.80	Issue Type +	Ma	Location *	WS
Category	Earthen Levee			GPS Latitude/Longitude	
				Start	End
Item	Trim / Thin Trees			38.226370 °	38.226370 °
				-121.525912 °	-121.525912 °
DWR ID	DWR_RD0563_01_s _ 2012_3				
Action/Comments					
Trim trees to at least five feet above ground level.

Looking southwest at overgrown trees on waterside slope.

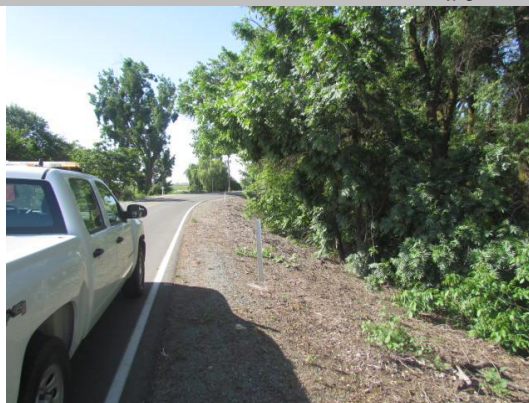
Photo 2 of 2 : richard_s_20140318_785.jpg

LM Start	0.80	Rating **	A/W	Issue No.	3 (cont)
LM End	0.80	Issue Type +	Ma	Location *	WS

Looking south at trimmed trees on waterward slope. (Spring 2013)

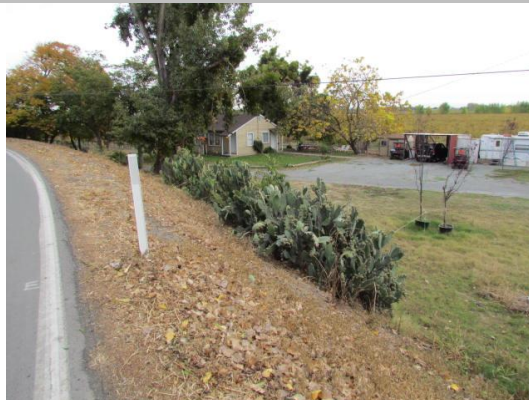
Photo 1 of 1 : richard_s_20140318_892.jpg

LM Start	0.86	Rating **	M	Issue No.	61
LM End	0.86	Issue Type +	En	Location *	LS
Category	Earthen Levee			GPS Latitude/Longitude	
				Start	End
Item	Vegetation				o
					o
DWR ID	DWR_RD0563_01_f_2012_61				
Action/Comments					
Landscaping

Looking northwest at cactus along landside toe.

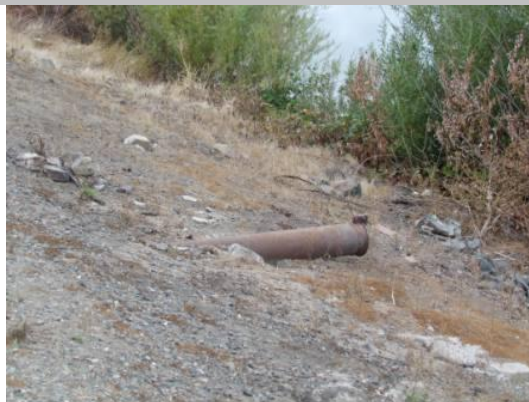
Photo 1 of 2 : richard_s_20140318_941.jpg

LM Start	0.98	Rating **	M	Issue No.	937
LM End	0.98	Issue Type +	Ma	Location *	CR
Category	Earthen Levee			GPS Latitude/Longitude	
				Start	End
Item	Encroachments			38.225813 °	38.225813 °
				-121.528198 °	-121.528198 °
DWR ID	DWR_RD0563_01_s_2012_937				
Action/Comments					
Pipe					
Inspector Comments: Abandoned pipe should be removed.

Looking southwest at pipe on waterside slope.

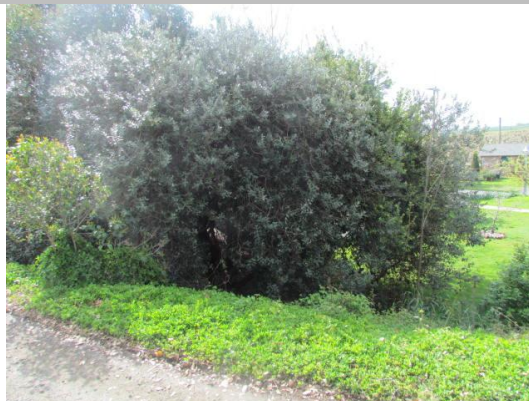
Photo 1 of 1 : richard_s_20140318_871.jpg

LM Start	1.12	Rating **	M	Issue No.	54
LM End	1.15	Issue Type +	En	Location *	LS
Category	Earthen Levee			GPS Latitude/Longitude	
				Start	End
Item	Vegetation			38.226933 °	38.227037 °
				-121.530307 °	-121.530850 °
DWR ID	DWR_RD0563_01_s _ 2012_54				
Action/Comments					
Landscaping

Looking east at landscaping on landside slope.

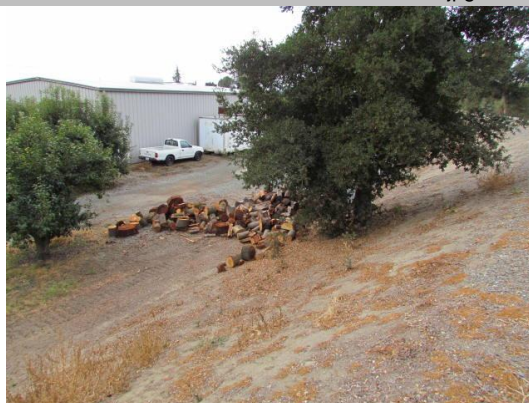
Photo 1 of 2 : richard_s_20140318_893.jpg

LM Start	1.21	Rating **	M	Issue No.	63
LM End	1.21	Issue Type +	Ma	Location *	LS
Category	Earthen Levee			GPS Latitude/Longitude	
				Start	End
Item	Encroachments				°
					°
DWR ID	DWR_RD0563_01_f_2012_63				
Action/Comments					
Firewood					
Inspector Comments: Firewood at landside toe.

Looking southwest at firewood at landside toe.

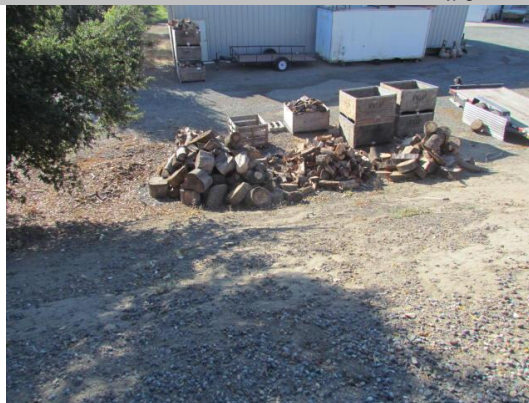
Photo 2 of 2 : richard_s_20140318_894.jpg

LM Start	1.21	Rating **	M	Issue No.	63 (cont)
LM End	1.21	Issue Type +	Ma	Location *	LS

Looking east at firewood stacked at landward toe.

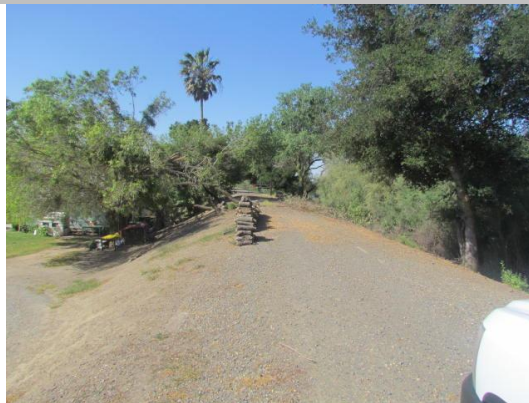
Photo 1 of 1 : richard_s_20140318_896.jpg

LM Start	1.23	Rating **	A/W	Issue No.	65
LM End	1.25	Issue Type +	En	Location *	LS
Category	Earthen Levee			GPS Latitude/Longitude	
				Start	End
Item	Encroachments			38.226558 °	38.226155 °
				-121.532088 °	-121.532427 °
DWR ID	DWR_RD0563_01_s_2013_65				
Action/Comments					
Firewood

Looking south at firewood piled on landward and waterward shoulder.

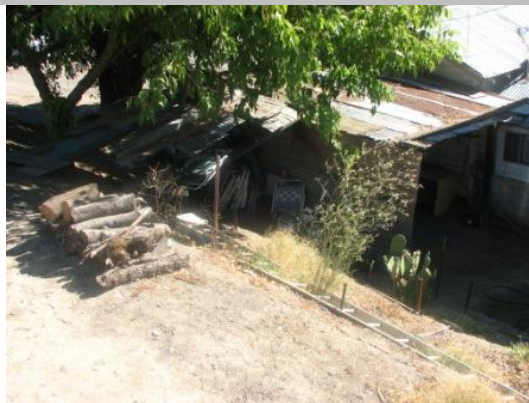
Photo 1 of 2 : richard_s_20140318_878.jpg

LM Start	1.25	Rating **	M	Issue No.	57
LM End	1.25	Issue Type +	En	Location *	LS
Category	Earthen Levee			GPS Latitude/Longitude	
				Start	End
Item	Encroachments			38.226345 °	38.226345 °
				-121.532332 °	-121.532332 °
DWR ID	DWR_RD0563_01_s _ 2012_57				
Action/Comments					
Building Inspector Comments: Landowner is stacking firewood and other items on landside slope and toe.

Looking at a shed at landside toe.

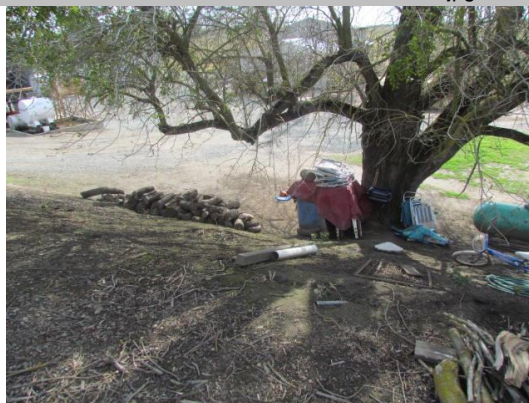
Photo 2 of 2 : richard_s_20140318_879.jpg

LM Start	1.25	Rating **	M	Issue No.	57 (cont)
LM End	1.25	Issue Type +	En	Location *	LS
Category	Earthen Levee			GPS Latitude/Longitude	
				Start	End
Item	Encroachments			38.226345 °	38.226345 °
				-121.532332 °	-121.532332 °
DWR ID	DWR_RD0563_01_s _ 2012_57				
Action/Comments					
Building Inspector Comments: Landowner is stacking firewood and other items on landside slope and toe.

Looking east at firewood and other materials stored on landside slope and toe.

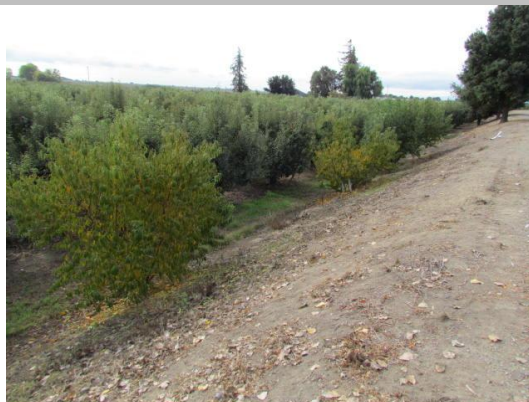
Photo 1 of 1 : richard_s_20140318_895.jpg

LM Start	1.30	Rating **	M	Issue No.	64
LM End	1.30	Issue Type +	Ma	Location *	LS
Category	Earthen Levee			GPS Latitude/Longitude	
				Start	End
Item	Trim / Thin Trees			38.225730 °	38.225730 °
				-121.532824 °	-121.532824 °
DWR ID	DWR_RD0563_01_f _ 2012_64				
Action/Comments					
Trim trees to at least five feet above ground level. Inspector Comments: Trees located at landside toe.

Looking southeast at fruit trees on landside toe.

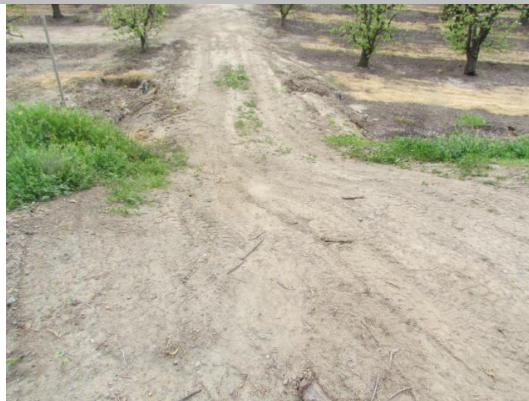
Photo 1 of 2 : richard_s_20140328_467.jpg

LM Start	1.37	Rating **	M	Issue No.	141
LM End	1.37	Issue Type +	En	Location *	LS
Category	Earthen Levee			GPS Latitude/Longitude	
				Start	End
Item	Encroachments				°
					°
DWR ID	DWR_RD0563_01_s _ 2014_141				
Action/Comments					
Ramp					
Inspector Comments: Landowner installed ramp without Board permit.

Looking east at ramp on landward slope.

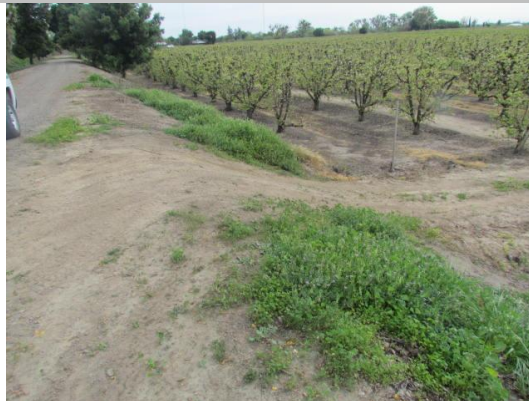
Photo 2 of 2 : richard_s_20140328_468.jpg

LM Start	1.37	Rating **	M	Issue No.	141 (cont)
LM End	1.37	Issue Type +	En	Location *	LS

Looking northeast at ramp on landward slope.

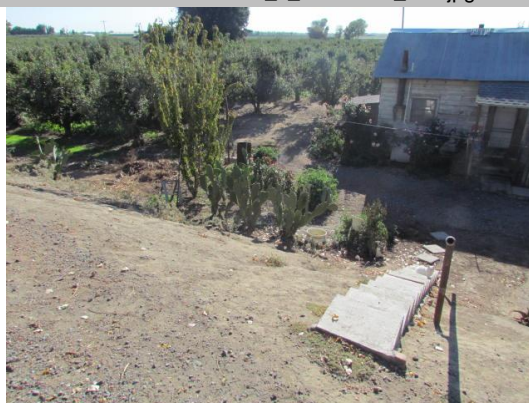
Photo 1 of 2 : richard_s_20140318_923.jpg

LM Start	1.43	Rating **	M	Issue No.	86
LM End	1.43	Issue Type +	En	Location *	LS
Category	Earthen Levee			GPS Latitude/Longitude	
				Start	End
Item	Vegetation			38.224351 °	38.224351 °
				-121.534209 °	-121.534209 °
DWR ID	DWR_RD0563_01_f _ 2013_86				
Action/Comments					
Landscaping

Looking east at cactus at the landward toe.

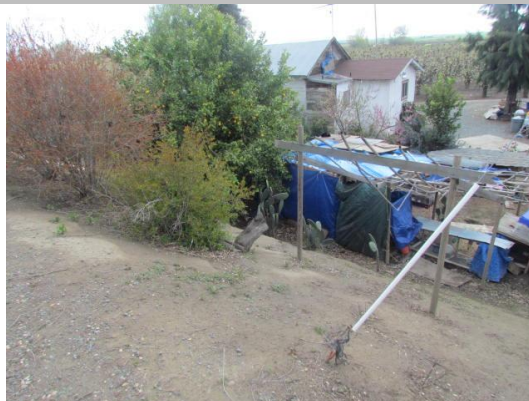
Photo 1 of 3 : richard_s_20140318_789.jpg

LM Start	1.43	Rating **	U	Issue No.	8
LM End	1.43	Issue Type +	En	Location *	LS
Category	Earthen Levee			GPS Latitude/Longitude	
				Start	End
Item	Encroachments			38.224315 °	38.224315 °
				-121.534288 °	-121.534288 °
DWR ID	DWR_RD0563_01_s_2012_8				
Action/Comments					
Building

Looking east at landscaping and animal containers on the landside slope and toe.

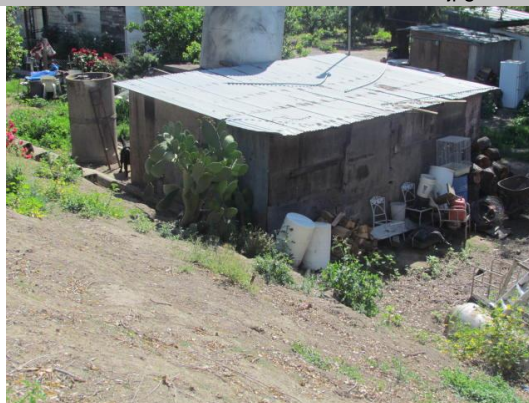
Photo 3 of 3 : richard_s_20140318_791.jpg

LM Start	1.43	Rating **	U	Issue No.	8 (cont)
LM End	1.43	Issue Type +	En	Location *	LS

Looking northeast at a tool shed on the landward toe.

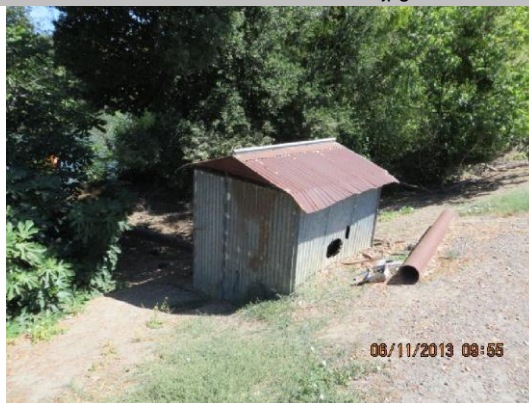
Photo 1 of 1 : UCIP_1150.jpg

LM Start	1.43	Rating **	M	Issue No.	113
LM End	1.43	Issue Type +	En	Location *	LS
Category	Supplemental			GPS Latitude/Longitude	
				Start	End
Item	DWR UCIP Field Study			38.224301 °	38.224301 °
				-121.534287 °	-121.534287 °
DWR ID	DWR_RD0563_01_s _ 2014_113				
Action/Comments					
Inspector Comments: FS_ID:14873

Pipe goes to pumphouse on WS slope.

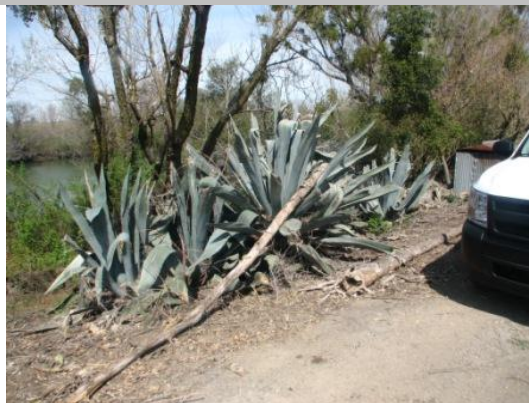
Photo 1 of 2 : richard_s_20140318_787.jpg

LM Start	1.44	Rating **	M	Issue No.	6
LM End	1.48	Issue Type +	Ma	Location *	WS
Category	Earthen Levee			GPS Latitude/Longitude	
				Start	End
Item	Vegetation			38.224280 °	38.224000 °
				-121.534377 °	-121.535038 °
DWR ID	DWR_RD0563_01_s _ 2012_6				
Action/Comments					
Remove the wild growth other than native grasses from the levee slopes.					
Inspector Comments: Remove century plant from waterward shoulder.

Century plant on waterward shoulder at LM 1.42

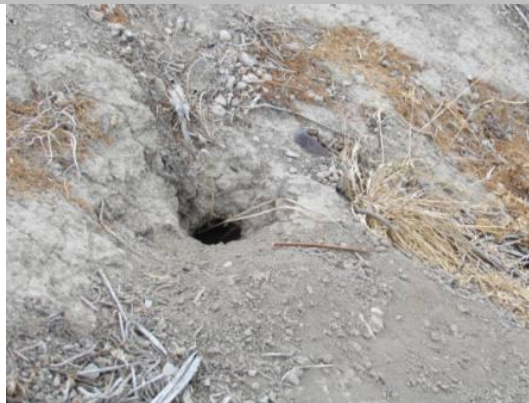
Photo 1 of 1 : richard_s_20140318_917.jpg

LM Start	1.68	Rating **	M	Issue No.	83
LM End	1.77	Issue Type +	Ma	Location *	LS
Category	Earthen Levee			GPS Latitude/Longitude	
				Start	End
Item	Animal Control			38.222967 °	38.222967 °
				-121.540055 °	-121.540055 °
DWR ID	DWR_RD0563_01_s _ 2012_83				
Action/Comments					
Exterminate rodents and backfill and compact or grout burrows.

Looking west at rodent hole on landside slope.

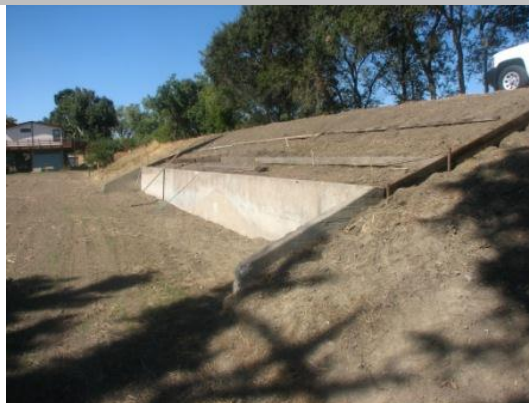
Photo 1 of 12 : richard_s_20140318_880.jpg

LM Start	1.86	Rating **	M	Issue No.	60
LM End	1.86	Issue Type +	En	Location *	LS
Category	Earthen Levee			GPS Latitude/Longitude	
				Start	End
Item	Encroachments			38.222702 °	38.222702 °
				-121.541678 °	-121.541678 °
DWR ID	DWR_RD0563_01_s _ 2012_60				
Action/Comments					
Stairway Inspector Comments: Landowner has built a pad on the landside shoulder, 60' x 15', for a metal walkway leading from the house to a pad with a concrete deadman. Landowner also installed a temporary stairway on landside slope and stairway on waterside slope. Electrical conduit on landside toe.

Unauthorized retaining wall on landside toe.

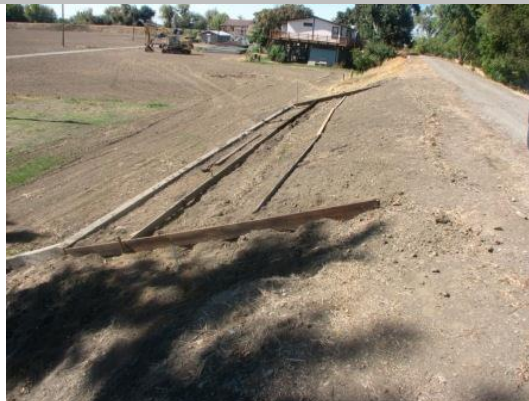
Photo 2 of 12 : richard_s_20140318_881.jpg

Looking southeast at top of retaining wall.

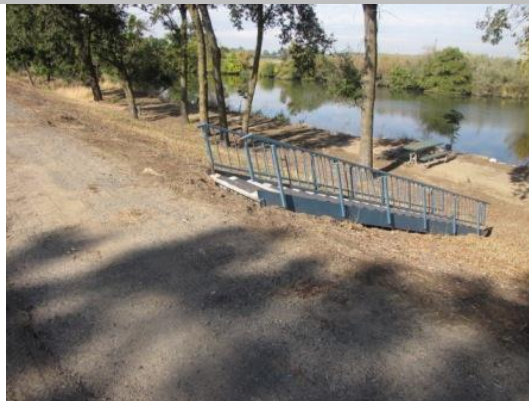
Photo 4 of 12 : richard_s_20140318_883.jpg

Looking west at metal stairs on waterside slope.

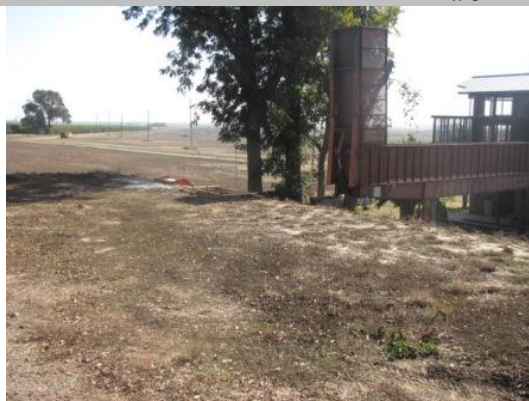
Photo 5 of 12 : richard_s_20140318_884.jpg

Looking northeast metal walkway on landside of levee.

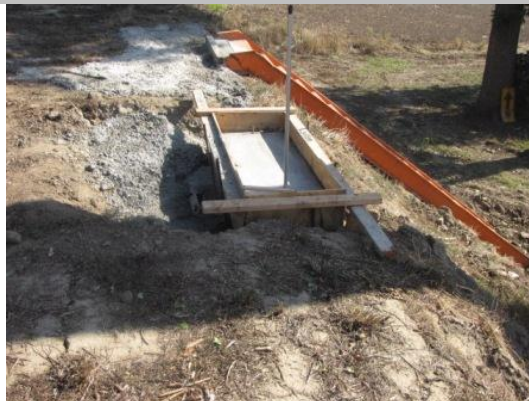
Photo 6 of 12 : richard_s_20140318_885.jpg

Looking north at deadman for metal walkway on earthen pad on landside shoulder.

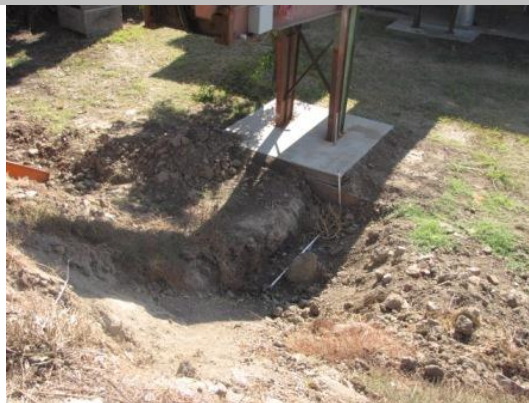
Photo 7 of 12 : richard_s_20140318_886.jpg

Looking east at electrical conduit in trench on landside toe and concrete pad for walkway.

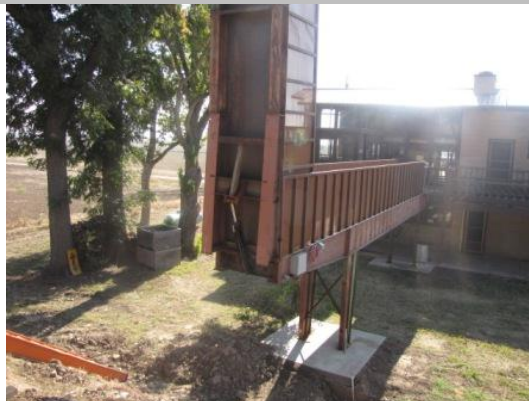
Photo 8 of 12 : richard_s_20140318_887.jpg

Looking east at metal walkway on landside.

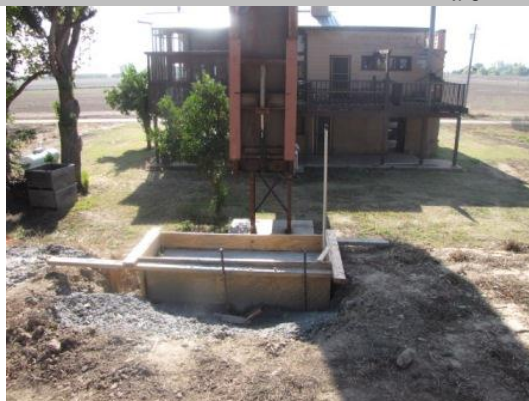
Photo 9 of 12 : richard_s_20140318_888.jpg

Looking east at deadman on landside shoulder.

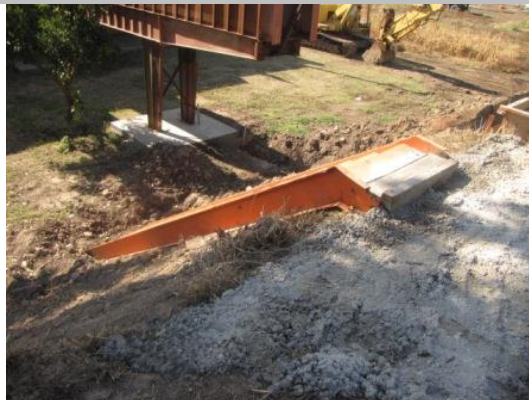
Photo 10 of 12 : richard_s_20140318_889.jpg

Looking southeast at temporary metal stairs on landside slope.

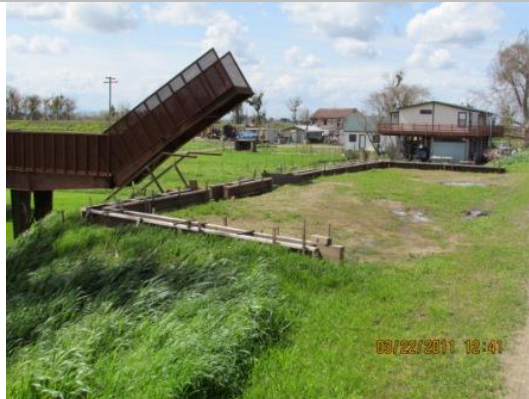
Photo 11 of 12 : richard_s_20140318_890.jpg

Looking southeast at framing for footings on landside shoulder.

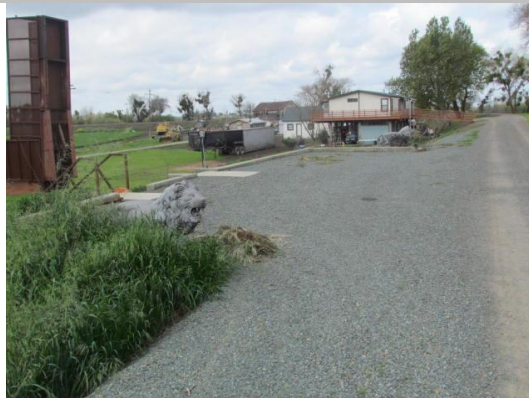
Photo 12 of 12 : richard_s_20140318_891.jpg

Looking south at retaining wall on landside shoulder. (Updated Spring 2012)

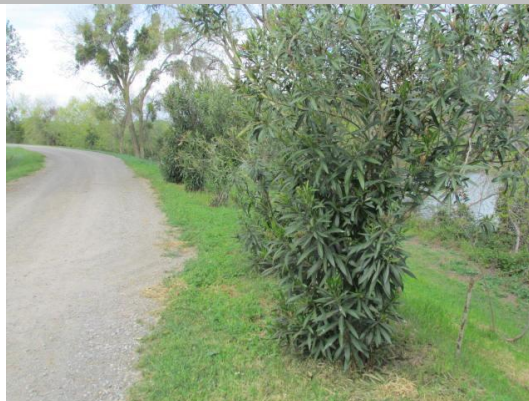
Photo 1 of 2 : richard_s_20140328_469.jpg

LM Start	1.90	Rating **	M	Issue No.	142
LM End	1.92	Issue Type +	En	Location *	WS
Category	Earthen Levee			GPS Latitude/Longitude	
				Start	End
Item	Vegetation				°
					°
DWR ID	DWR_RD0563_01_s_2014_142				
Action/Comments					
Landscaping

Looking southwest at oleanders on waterward shoulder.

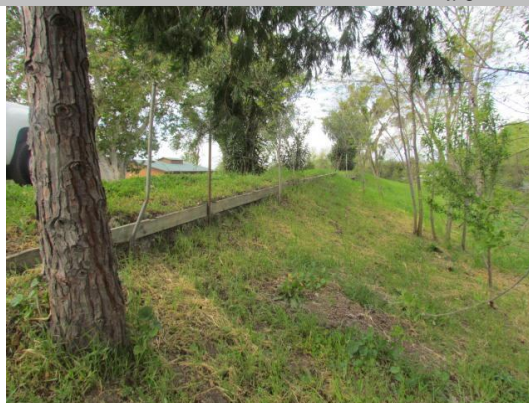
Photo 2 of 2 : richard_s_20140328_470.jpg

Looking southeast at planting box on waterward shoulder.

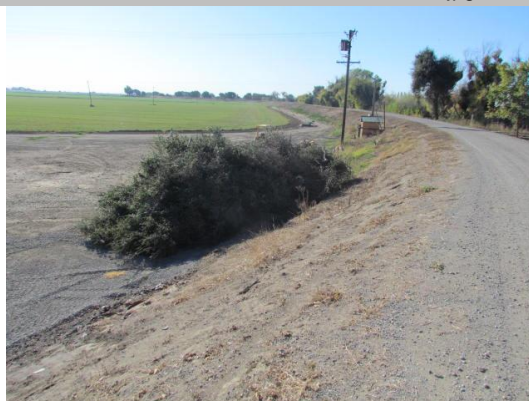
Photo 1 of 4 : richard_s_20140318_936.jpg

LM Start	1.98	Rating **	M	Issue No.	96
LM End	1.98	Issue Type +	Ma	Location *	LS
Category	Earthen Levee			GPS Latitude/Longitude	
				Start	End
Item	Encroachments			38.222094 °	38.222094 °
				-121.543435 °	-121.543435 °
DWR ID	DWR_RD0563_01_f_2013_96				
Action/Comments					
Prunings

Looking southeast at prunings at landward toe.

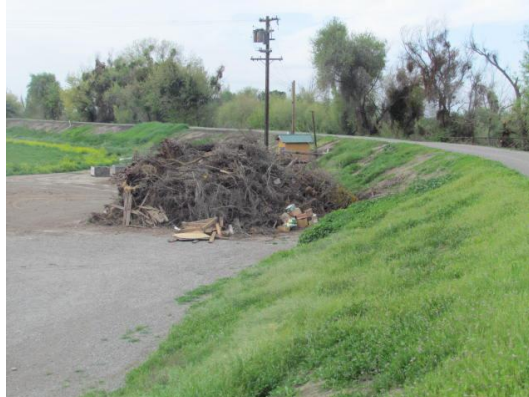
Photo 2 of 4 : richard_s_20140328_471.jpg

LM Start	1.98	Rating **	M	Issue No.	96 (cont)
LM End	1.98	Issue Type +	Ma	Location *	LS
Category	Earthen Levee			GPS Latitude/Longitude	
				Start	End
Item	Encroachments			38.222094 °	38.222094 °
				-121.543435 °	-121.543435 °
DWR ID	DWR_RD0563_01_f_2013_96				
Action/Comments					
Prunings					
Inspector Comments: Large pruning pile at landward toe.

Looking south at pruning pile at landward toe.

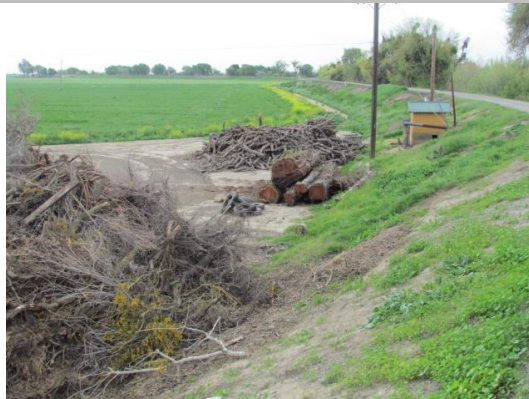
Photo 3 of 4 : richard_s_20140328_472.jpg

Looking south at additional pruning piles at landward toe.

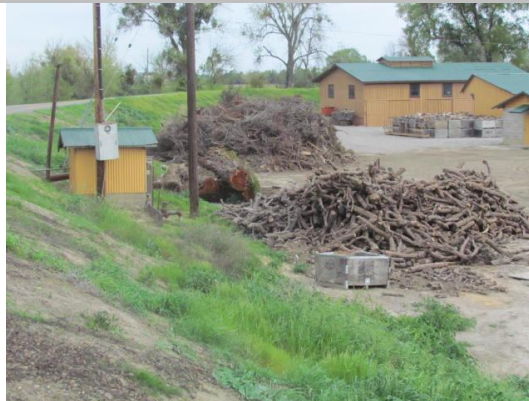
Photo 4 of 4 : richard_s_20140328_473.jpg

Looking north at pruning piles at landward toe.

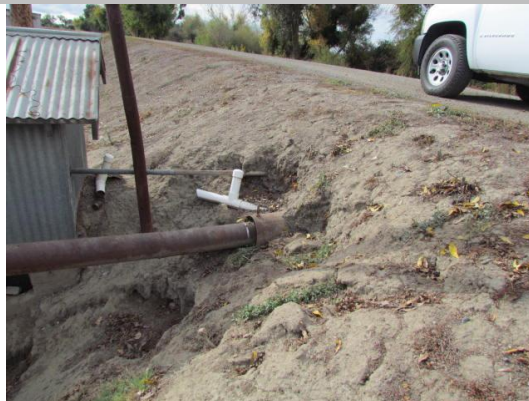
Photo 1 of 2 : richard_s_20140318_899.jpg

LM Start	2.00	Rating **	M	Issue No.	71
LM End	2.00	Issue Type +	Ma	Location *	LS
Category	Earthen Levee			GPS Latitude/Longitude	
				Start	End
Item	Erosion / Bank Caving				°
					°
DWR ID	DWR_RD0563_01_f_2012_71				
Action/Comments					
Note and monitor erosion site.

Looking southwest at erosion around irrigation pipe on landside slope and toe.

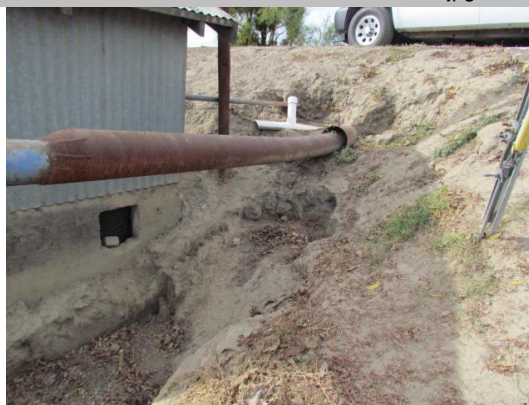
Photo 2 of 2 : richard_s_20140318_900.jpg

Looking west at erosion at landside toe and slope next to pump house.

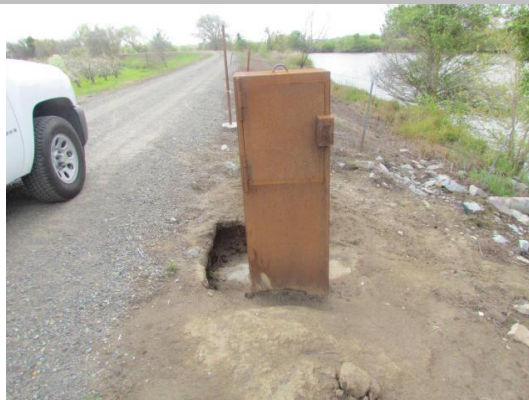
Photo 1 of 1 : richard_s_20140318_800.jpg

LM Start	2.23	Rating **	M	Issue No.	15
LM End	2.23	Issue Type +	En	Location *	WS
Category	Earthen Levee			GPS Latitude/Longitude	
				Start	End
Item	Encroachments			38.218575 °	38.218575 °
				-121.542668 °	-121.542668 °
DWR ID	DWR_RD0563_01_s _ 2012_15				
Action/Comments					
Equipment					
Inspector Comments: Landowner installed metal box around siphon breaker.

Looking south at siphon box installed on waterside shoulder.

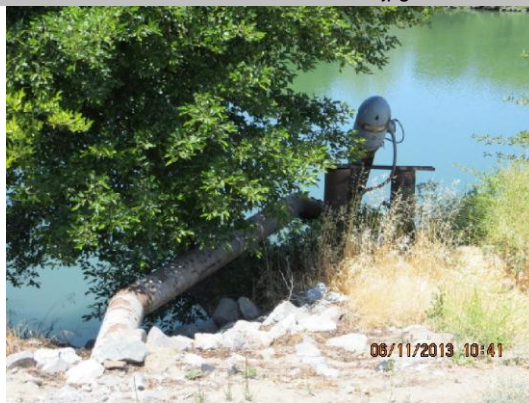
Photo 1 of 1 : UCIP_1157.jpg

UCIP Comments: Concrete standpipe on LS toe is not functioning properly. Leaks springing up in the ground around the standpipe. This may erode the soil at base of levee.

FIELD_STRUCT_DESC: 1 of 2: 12-inch pipe through levee 3.0 feet below crown (Permit No. 13311, 1982). Slant pump on WS toe. 36-inch concrete standpipe and pipe works on LS toe. Siphon breaker in 24-inch CMP riser on LS shoulder. Pipe replaced 12-inch pipe from O&M manual/Permit No. 11207.

Slant pump and pipe on WS slope.

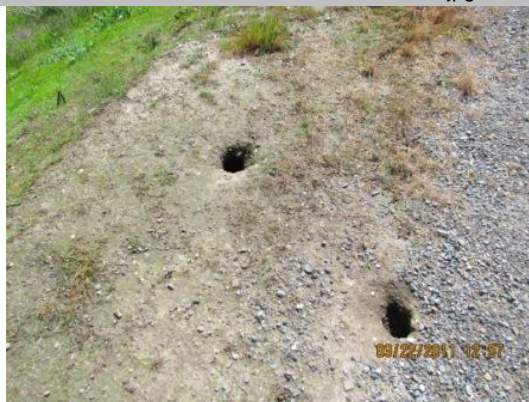
Photo 1 of 1 : richard_s_20140318_815.jpg

Inspector Comments: Rodent holes on landside shoulder.

Looking southeast at squirrel holes on landside shoulder.

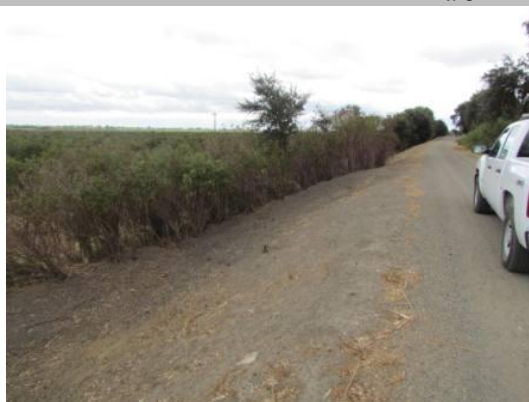
Photo 2 of 2 : richard_s_20140318_797.jpg

Look southeast at updated (10/11) view of elderberries on landside slope.

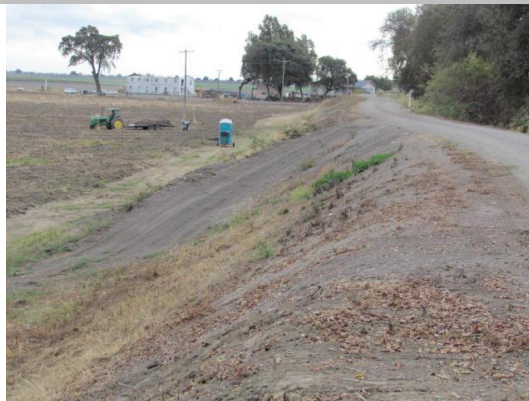
Photo 1 of 1 : richard_s_20140318_901.jpg

LM Start	2.44	Rating **	M	Issue No.	72
LM End	2.44	Issue Type +	En	Location *	LS
Category	Earthen Levee			GPS Latitude/Longitude	
				Start	End
Item	Encroachments				°
					°
DWR ID	DWR_RD0563_01_f_2012_72				
Action/Comments					
Ramp

Looking south at unauthorized ramp on landside slope.

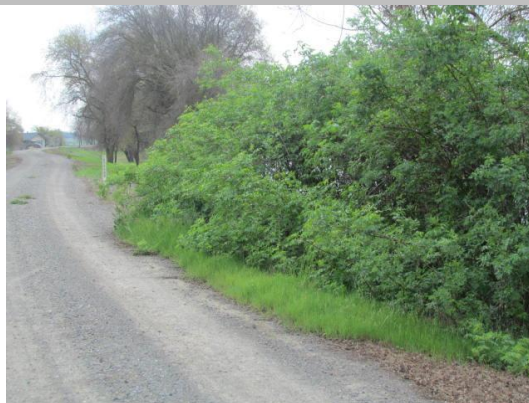
Photo 1 of 1 : richard_s_20140318_798.jpg

LM Start	2.46	Rating **	M	Issue No.	12
LM End	2.46	Issue Type +	Ma	Location *	WS
Category	Earthen Levee			GPS Latitude/Longitude	
				Start	End
Item	Vegetation			38.216122 °	38.216047 °
				-121.540555 °	-121.540415 °
DWR ID	DWR_RD0563_01_s_2012_12				
Action/Comments					
Elderberries are blocking visibility and flood fight capability.

Looking southwest at dense elderberry brush on waterside shoulder and slope.

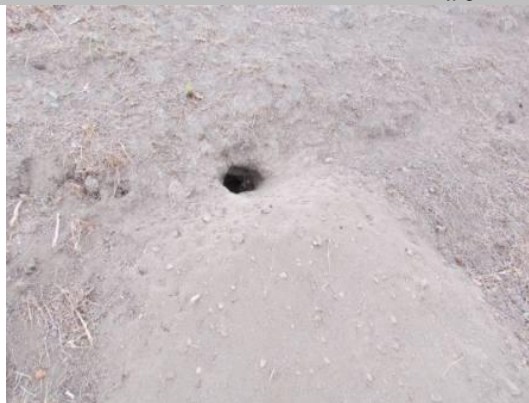
Photo 1 of 4 : richard_s_20140318_919.jpg

LM Start	2.58	Rating **	M	Issue No.	85
LM End	2.61	Issue Type +	Ma	Location *	LS
Category	Earthen Levee			GPS Latitude/Longitude	
				Start	End
Item	Animal Control			38.215082 °	38.214852 °
				-121.538652 °	-121.538305 °
DWR ID	DWR_RD0563_01_s_2012_85				
Action/Comments					
No rodents visible, but rodent burrows visible; need to backfill and compact or grout burrows.

Looking west at rodent hole on landside slope.

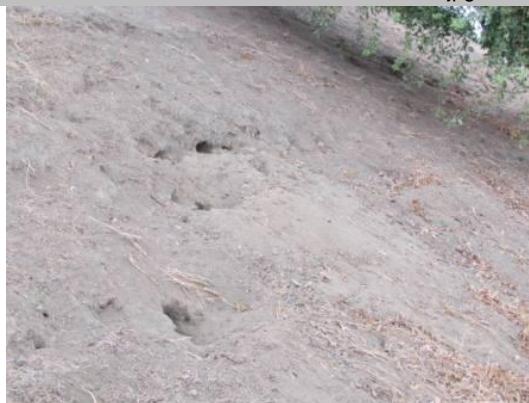
Photo 2 of 4 : richard_s_20140318_920.jpg

Looking northeast at rodent holes on landside slope.

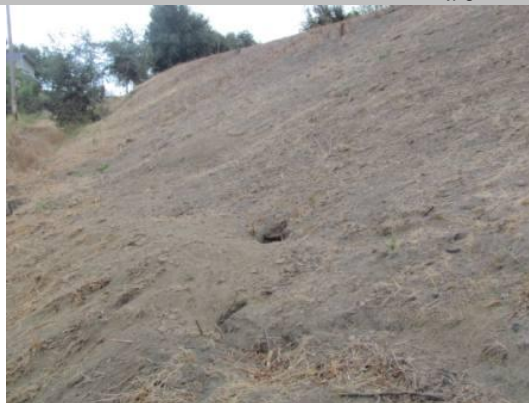
Photo 3 of 4 : richard_s_20140318_921.jpg

Looking southwest at rodent holes on landside slope.

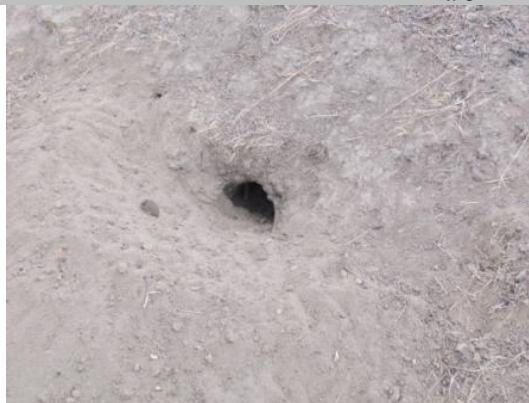
Photo 4 of 4 : richard_s_20140318_922.jpg

Looking east at rodent hole on landside slope.

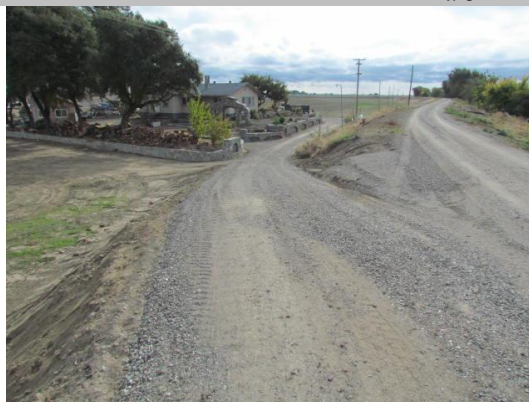
Photo 1 of 2 : richard_s_20140318_914.jpg

LM Start	2.62	Rating **	M	Issue No.	80
LM End	2.62	Issue Type +	En	Location *	LS
Category	Earthen Levee			GPS Latitude/Longitude	
				Start	End
Item	Encroachments				°
					°
DWR ID	DWR_RD0563_01_f_2012_80				
Action/Comments					
Ramp Inspector Comments: Landowner installed unauthorized ramp on landside slope.

Looking southeast at unauthorized ramp on landside slope.

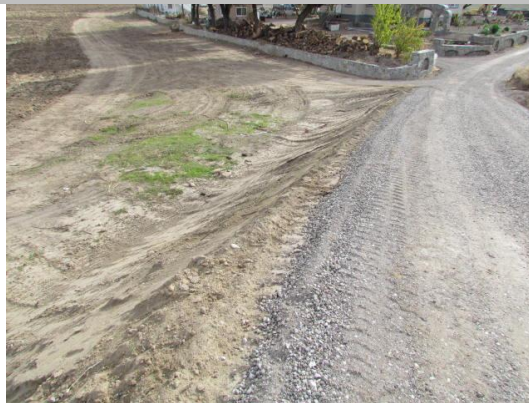
Photo 2 of 2 : richard_s_20140318_915.jpg

Looking east at unauthorized ramp on landside slope.

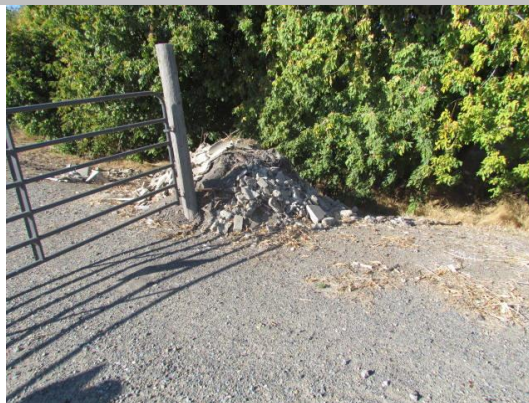
Photo 2 of 2 : richard_s_20140318_940.jpg

LM Start	2.95	Rating **	M	Issue No.	104
LM End	2.95	Issue Type +	Ma	Location *	LS
Category	Earthen Levee			GPS Latitude/Longitude	
				Start	End
Item	Encroachments			38.210966 °	38.210966 °
				-121.534813 °	-121.534813 °
DWR ID	DWR_RD0563_01_f_2013_104				
Action/Comments					
Material					
Inspector Comments: Landowner stockpiled concrete rubble on landward and waterward slope to stop trespassers. Landowner should replace the stockpile with a proper fence.

Looking west at concrete rubble on waterward shoulder and slope.

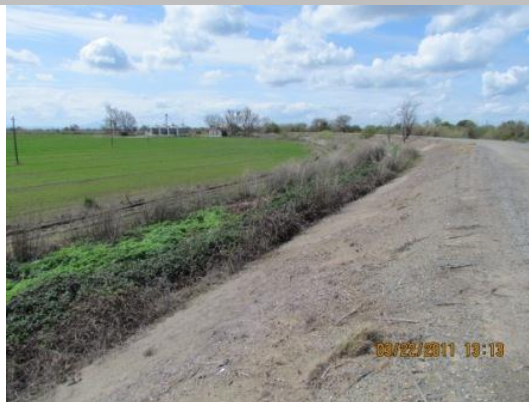
Photo 1 of 2 : richard_s_20140318_904.jpg

LM Start	3.09	Rating **	U	Issue No.	74
LM End	3.28	Issue Type +	Ma	Location *	LS
Category	Earthen Levee			GPS Latitude/Longitude	
				Start	End
Item	Vegetation			38.210212 °	38.209165 °
				-121.536728 °	-121.539920 °
DWR ID	DWR_RD0563_01_s_2012_74				
Action/Comments					
Remove the wild growth other than native grasses from the levee slopes.					
Inspector Comments: Dead berryvines at landside toe blocking view of toe.

Looking southeast at berryvines on landside toe.

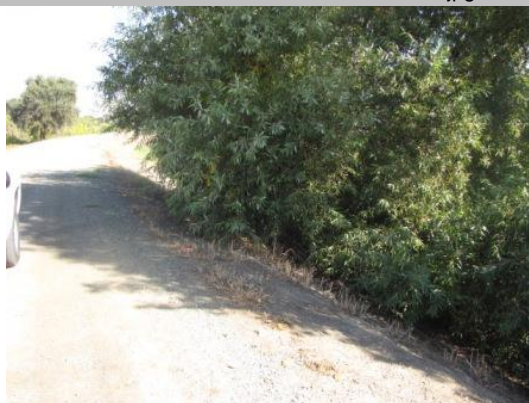
Photo 1 of 2 : richard_s_20140318_897.jpg

LM Start	3.28	Rating **	U	Issue No.	68
LM End	3.28	Issue Type +	Ma	Location *	LS
Category	Earthen Levee			GPS Latitude/Longitude	
				Start	End
Item	Trim / Thin Trees			38.209217 °	38.209217 °
				-121.539823 °	-121.539823 °
DWR ID	DWR_RD0563_01_s _ 2012_68				
Action/Comments					
Thin trees to allow visibility of the ground and room to flood fight.

Looking southeast at dense trees on landside slope and toe.

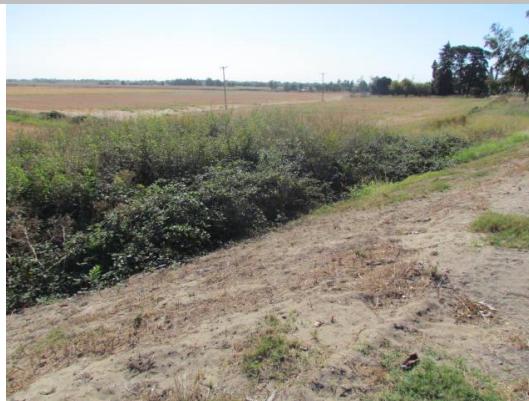
Photo 1 of 2 : richard_s_20140318_918.jpg

LM Start	3.50	Rating **	M	Issue No.	84
LM End	3.50	Issue Type +	Ma	Location *	LS
Category	Earthen Levee			GPS Latitude/Longitude	
				Start	End
Item	Vegetation				°
					°
DWR ID	DWR_RD0563_01_f_2012_84				
Action/Comments					
Remove the wild growth other than native grasses from the levee slopes.					
Inspector Comments: Vegetation at landward toe.

Looking southeast at dense berryvines on landward toe.

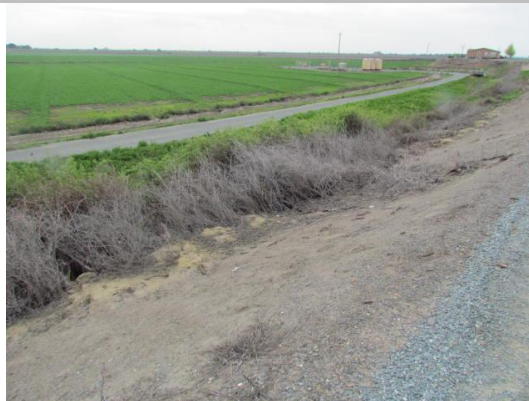
Photo 2 of 2 : richard_s_20140328_474.jpg

LM Start	3.50	Rating **	M	Issue No.	84 (cont)
LM End	3.50	Issue Type +	Ma	Location *	LS

Looking southeast at dead berryvines on landward toe.

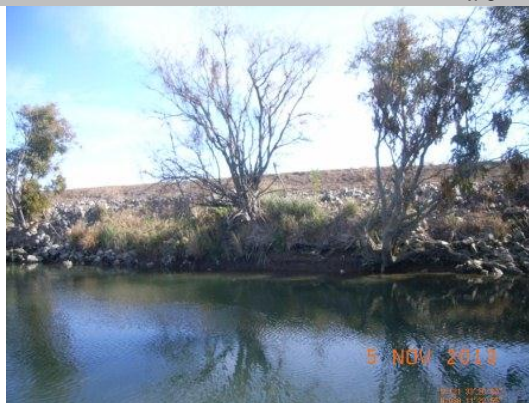
Photo 1 of 1 : USACE2013A_GEO_8-3_L_6.jpg

LM Start	4.00	Rating **	M	Issue No.	51
LM End	4.10	Issue Type +	Ma	Location *	WS
Category	Supplemental			GPS Latitude/Longitude	
				Start	End
Item	USACE Erosion Survey			38.200733 °	38.199925 °
				-121.542571 °	-121.544249 °
DWR ID					
Action/Comments					
Inspector Comments: 1997 - Narrow eroding berm upstream of existing

USACE 2013 Photo #1

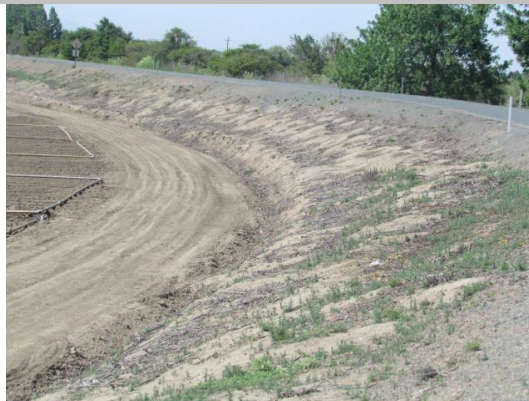
Photo 1 of 2 : richard_s_20140318_802.jpg

LM Start	4.05	Rating **	M	Issue No.	17
LM End	4.19	Issue Type +	En	Location *	LS
Category	Earthen Levee			GPS Latitude/Longitude	
				Start	End
Item	Encroachments			38.200238 °	38.198830 °
				-121.543308 °	-121.544913 °
DWR ID	DWR_RD0563_01_s _ 2013_17				
Action/Comments					
Ditch

Looking southwest at irrigation ditch on landward toe.

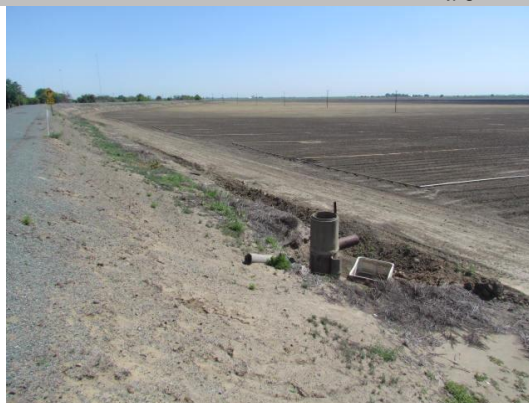
Photo 2 of 2 : richard_s_20140318_803.jpg

LM Start	4.05	Rating **	M	Issue No.	17 (cont)
LM End	4.19	Issue Type +	En	Location *	LS

Looking northeast at irrigation ditch on landward toe.

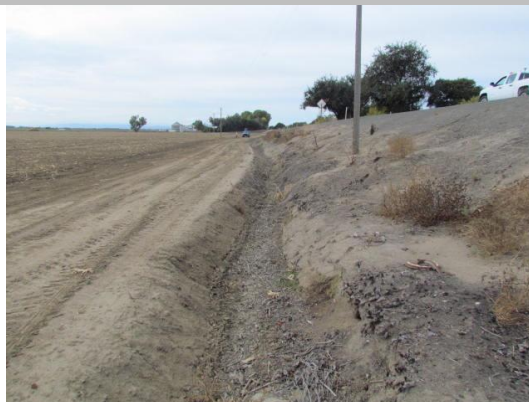
Photo 1 of 1 : richard_s_20140318_934.jpg

LM Start	4.48	Rating **	M	Issue No.	93
LM End	4.70	Issue Type +	Ob	Location *	LS
Category	Earthen Levee			GPS Latitude/Longitude	
				Start	End
Item	Encroachments				
DWR ID	DWR_RD0563_01_f_2012_93				
Action/Comments					
Ditch					
Inspector Comments: Ditch at landside toe should be removed.

Looking south at irrigation ditch at landside toe.

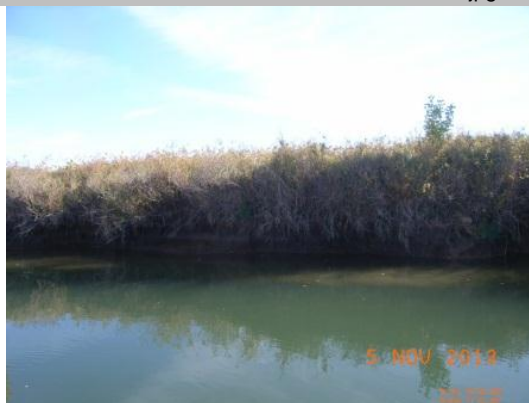
Photo 1 of 1 : USACE2013A_GEO_7-2_L_6.jpg

LM Start	5.04	Rating **	M	Issue No.	49
LM End	5.14	Issue Type +	Ma	Location *	WS
Category	Supplemental			GPS Latitude/Longitude	
				Start	End
Item	USACE Erosion Survey			38.190073 °	38.189524 °
				-121.556307 °	-121.557227 °
DWR ID					
Action/Comments					
Inspector Comments: 2009 - Small scallops of erosion into the levee toe behind brush boxes. 2011 - Minor new erosion. 2012 - Site extended upstream to account for addition erosion pockets. 2013: No observed changes. [2013 Site ID: GEO 7-2 L]

USACE 2013 Photo #1

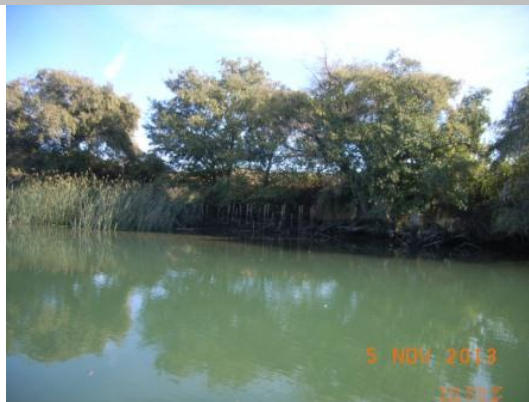
Photo 1 of 1 : USACE2013A_GEO_6-8_L_8.jpg

LM Start	5.26	Rating **	U	Issue No.	48
LM End	5.44	Issue Type +	Ma	Location *	WS
Category	Supplemental			GPS Latitude/Longitude	
				Start	End
Item	USACE Erosion Survey			38.188216 °	38.185968 °
				-121.558442 °	-121.561667 °
DWR ID					
Action/Comments					
Inspector Comments: 1997 - Deep pockets of erosion into a narrow berm just downstream of the rock. 2000 - Scallops in banks with small colored flags, some new biotech rolls in with older rolls in the scallops. 2001 - Staked , low fascine walls at the bankline. 2011 - Site upgraded to CRITICAL. Site extended upstream due to new erosion pocket. New tree popouts and new erosion. 2013: Pipe observed at upstream end of site. [2013 Site ID: GEO_6-8_L]

USACE 2013 Photo #1

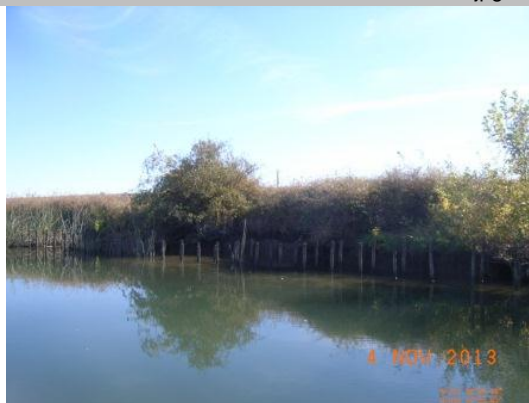
Photo 1 of 1 : USACE2013A_GEO_6-3_L_13.jpg

Inspector Comments: 1997 - Deep pockets of erosion and narrow berm. Reach is characterized by lots of pockets into the existing berm and/or levee slope. 1999 - Some pockets filled with rock riprap. 2000 - Exposed fabric. 2001 - Staked, low fascine walls at bankline. 2002 - New spot of rock at upstream end. Some new brush boxes. 2005 - Some stone sliding off the underlying geotextile fabric. Some new brush bundles in the brush boxes; some with missing bundles. Some boxes too low relative to high tide. 2009 - Minimal new erosion, site length extended. 2010 - New erosion on downstream end, site extended downstream. 2011 - Sites 6.1. 6.4 and 6.6 were combined. New erosion pockets, site extended to include the erosion in between the old sites. 2012 - Rock has been placed in portions of the bank since last year. 2013: No observed changes. [2013 Site ID: GEO_6-3_L]

USACE 2013 Photo #1

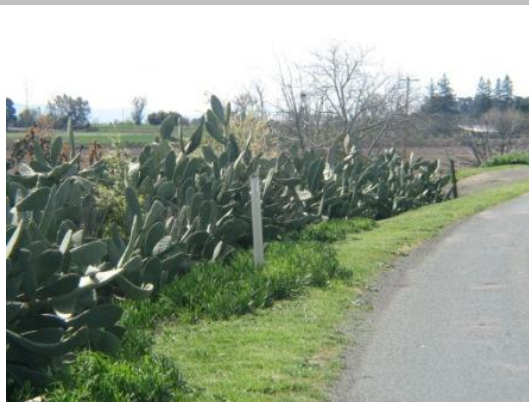
Photo 1 of 2 : richard_s_20140318_806.jpg

LM Start	6.04	Rating **	U	Issue No.	22
LM End	6.08	Issue Type +	Ma	Location *	LS
Category	Earthen Levee			GPS Latitude/Longitude	
				Start	End
Item	Vegetation			38.181965 °	38.181763 °
				-121.569913 °	-121.570447 °
DWR ID	DWR_RD0563_01_s_2012_22				
Action/Comments					
Remove the wild growth other than native grasses from the levee slopes.					
Inspector Comments: Large cactus on landward slope.

Large cactus plant on landward slope from LM 6.04 to 6.08
